Native “Lakescaping” to Protect Water Quality

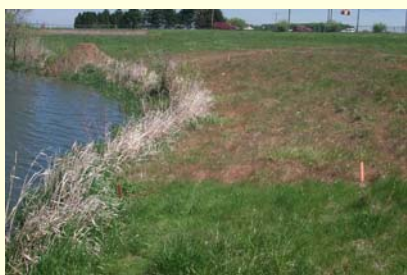
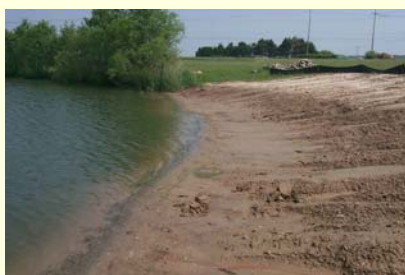
Side by side plots along a lake shoreline were treated to illustrate the potential benefits of native vegetation and erosion control structures. In figures 1-2 the plot areas are treated with herbicides, and sand is brought into the site. In figures 3-4, an erosion control structure made of coconut fiber (called a coir log) is laid down along the shoreline. Black fabric cloth, wooden stakes and rocks are used to keep the coir log in place and prevent back washing from wave action. The area is mulched and seeded with grass and plants in figures 5-6. Figure 7 shows the plot planted with native vegetation while figure 8 shows the plot planted with grass only during year one.

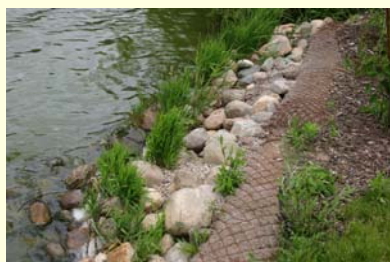
Figure 9

Figures 9-12 show the results during year two. The plot with the coir log and native vegetation (figures 9 and 11) has a stable shoreline, and native vegetation has begun growing within the rocks and log. The plot planted with grass (figures 10 and 12) has severe erosion along the shoreline. Geese feathers and droppings are prominent within the plot while the neighboring plot shows little evidence of geese congregating in the area.
